INSPECTION REPORT: KENSINGTON GOLD MINE

Date of Inspection: Thursday July 29, 2021
Date of Report: 08/10/2021
USDA Forest Service Inspector: Casey Loofbourrow

Sites visited during the inspection included: access roads, Comet Development Pile, Comet Water Treatment Plant (CWTP), Sherman Creek Outfall 001, Comet Beach, Comet access road bridges, Revegetation test plot, Pit 4, Pit 1, and the Tailings Treatment Facility (TTF) area, Fuel Depot, and the Slate Cove Marine Terminal.

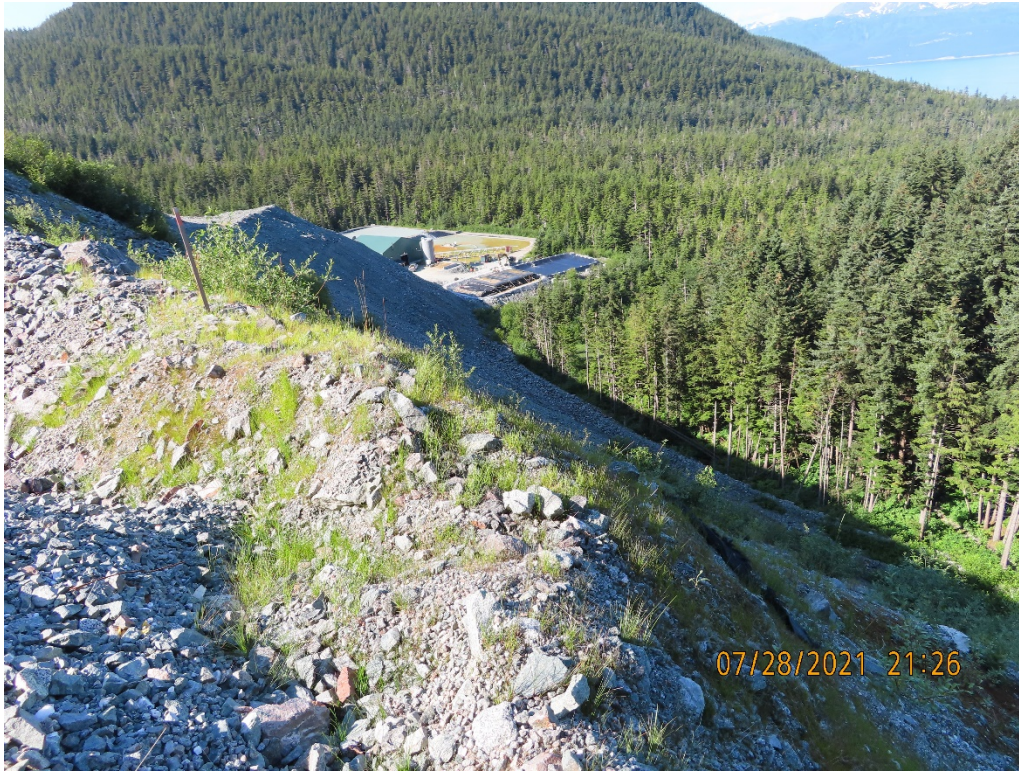
The slopes of the Comet waste rock storage area appear stable (Photo 1).

Photo 1. Comet Development Pile looking south.

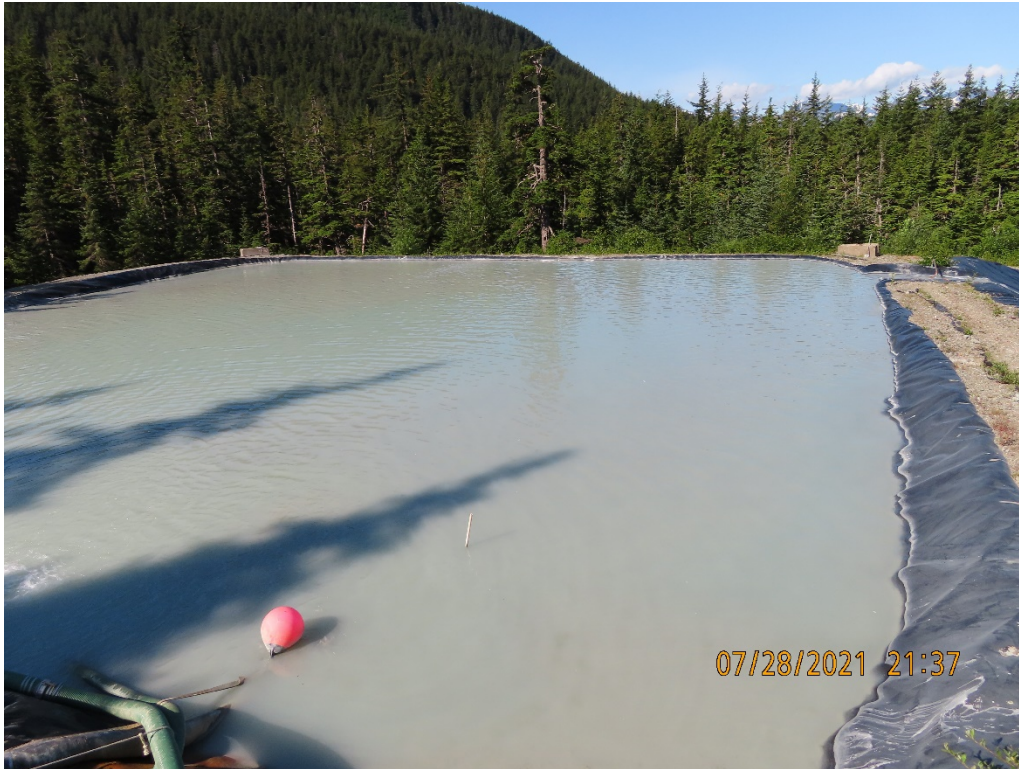
The CWTP was treating approximately 2,463 gallons per minute (gpm). Ponds 1 and 2 were in good condition and functioning as designed (Photos 2-3). The mobile water treatment plant, referred to as plant 2.5, was operating.

Photo 2. Comet Pond 1.

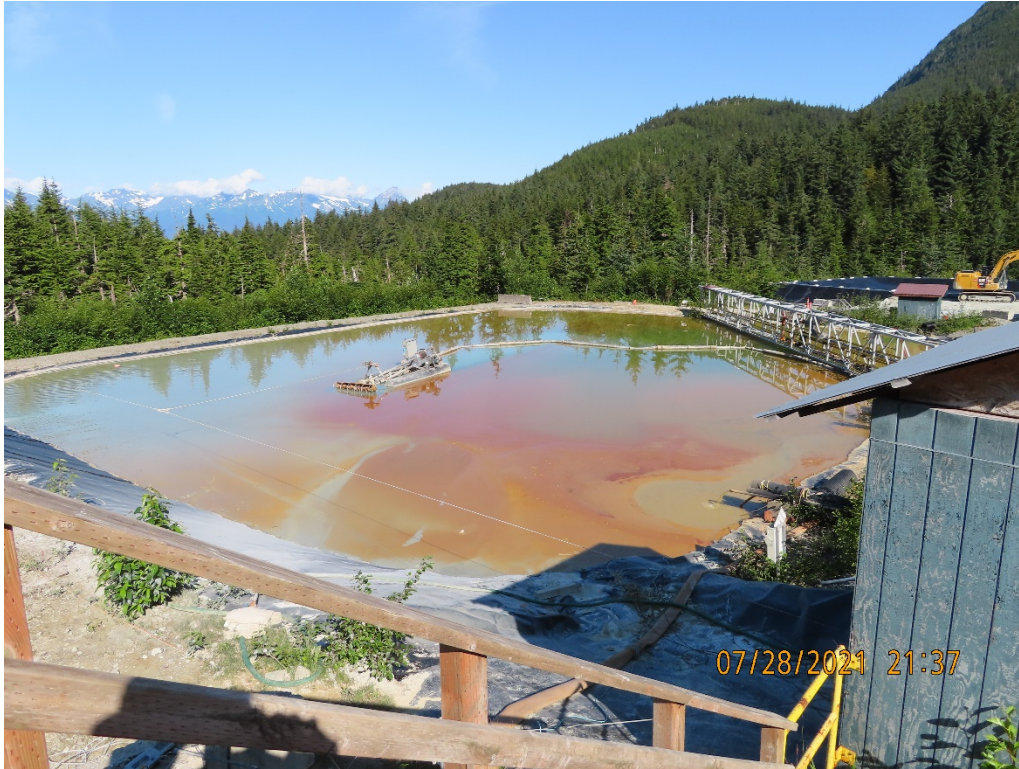
Photo 3. Comet Pond 2.

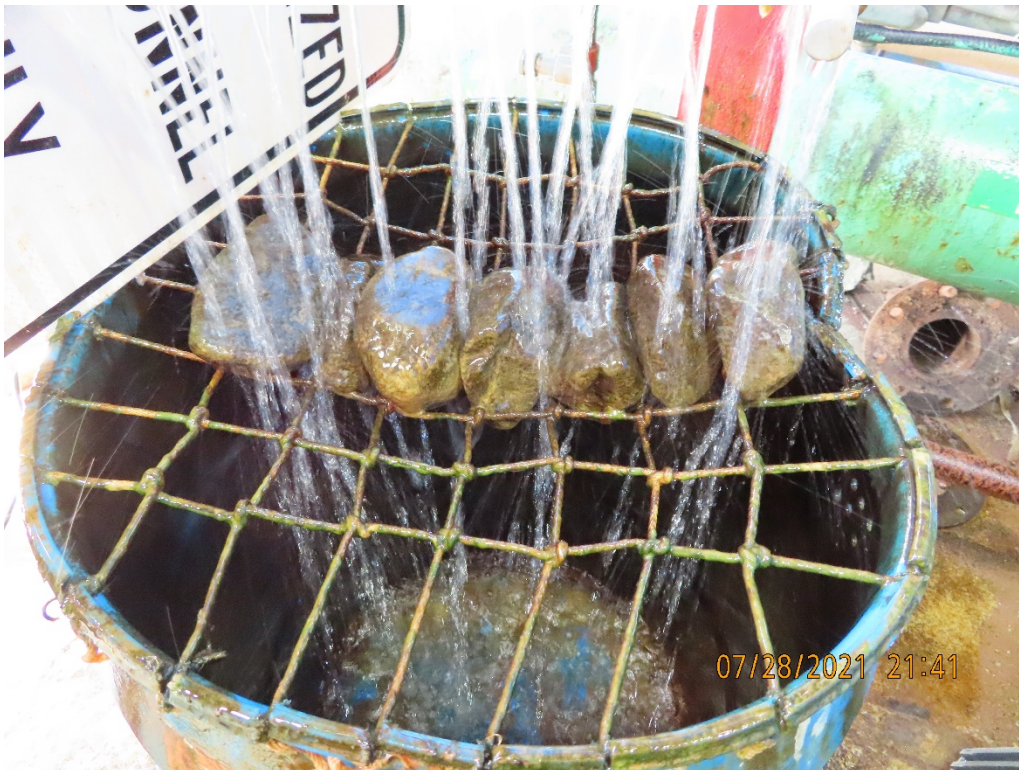
White material was not observed on the test rocks used for monitoring in the CWTP (Photo 4).

Photo 4. Test rocks for white material accumulation in CWTP.

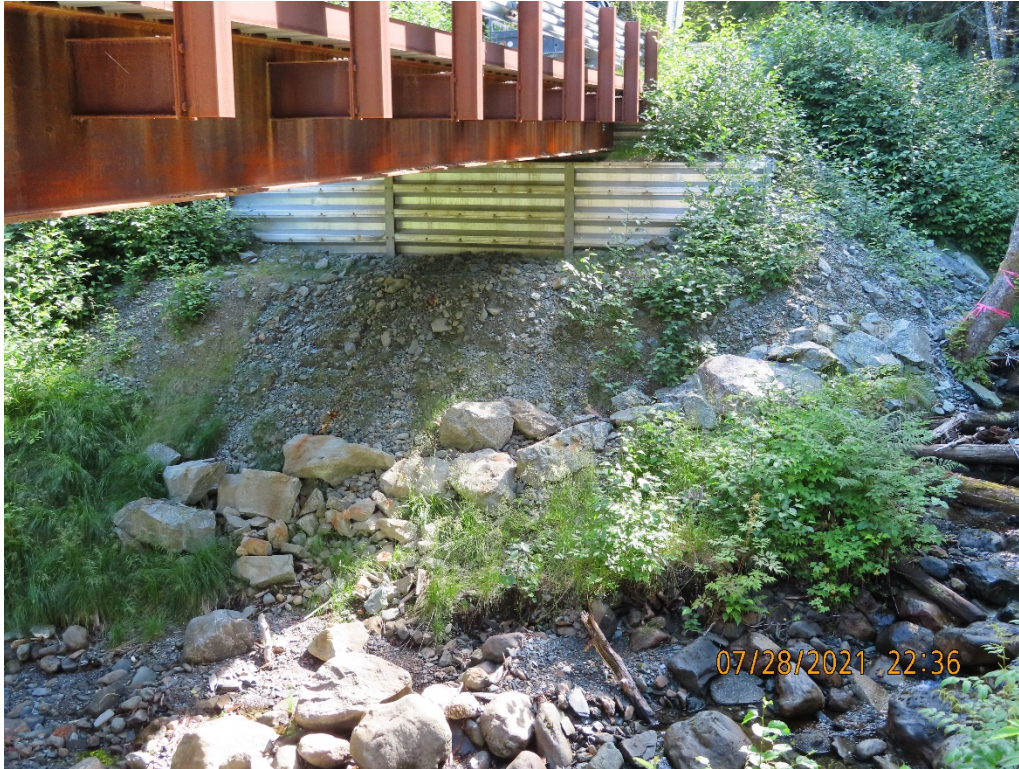
No Name Creek Bridge and abutments were in good condition with no evidence of erosion or sedimentation (Photo 5).

Photo 5. No Name Creek bridge abutment.

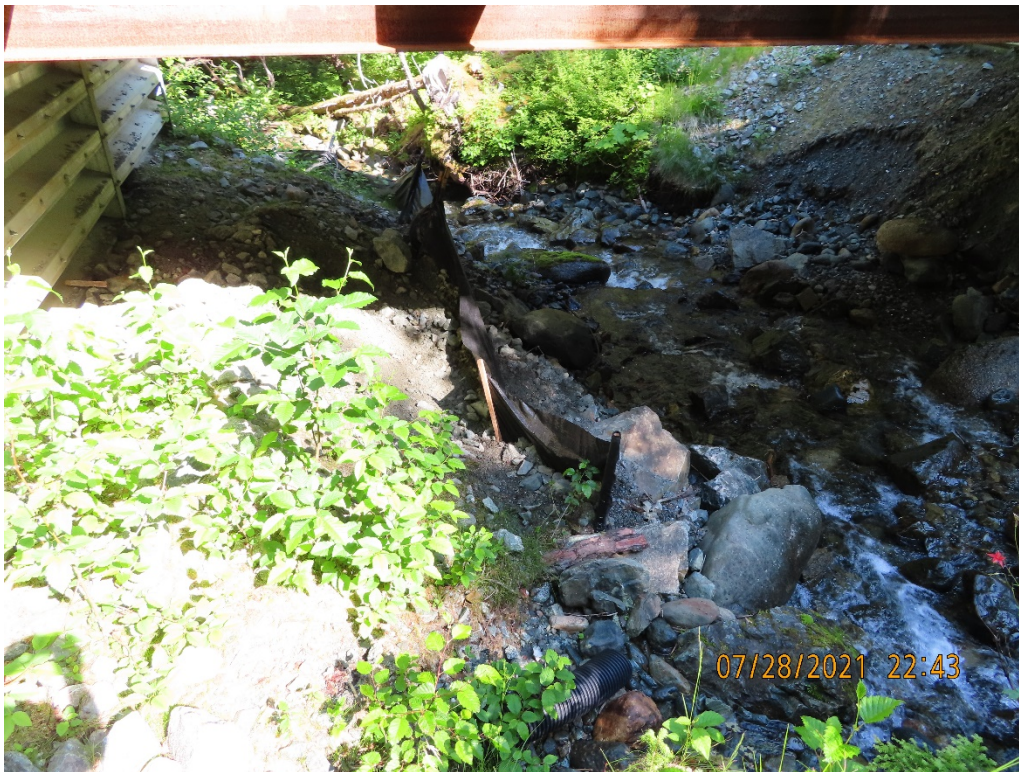
A previous action item (181-1) was to repair the Sherman Creek Bridge downhill side abutment silt fencing. This has been repaired and is in good condition (Photo 6).

Photo 6. Sherman Creek bridge abutment repaired silt fencing.

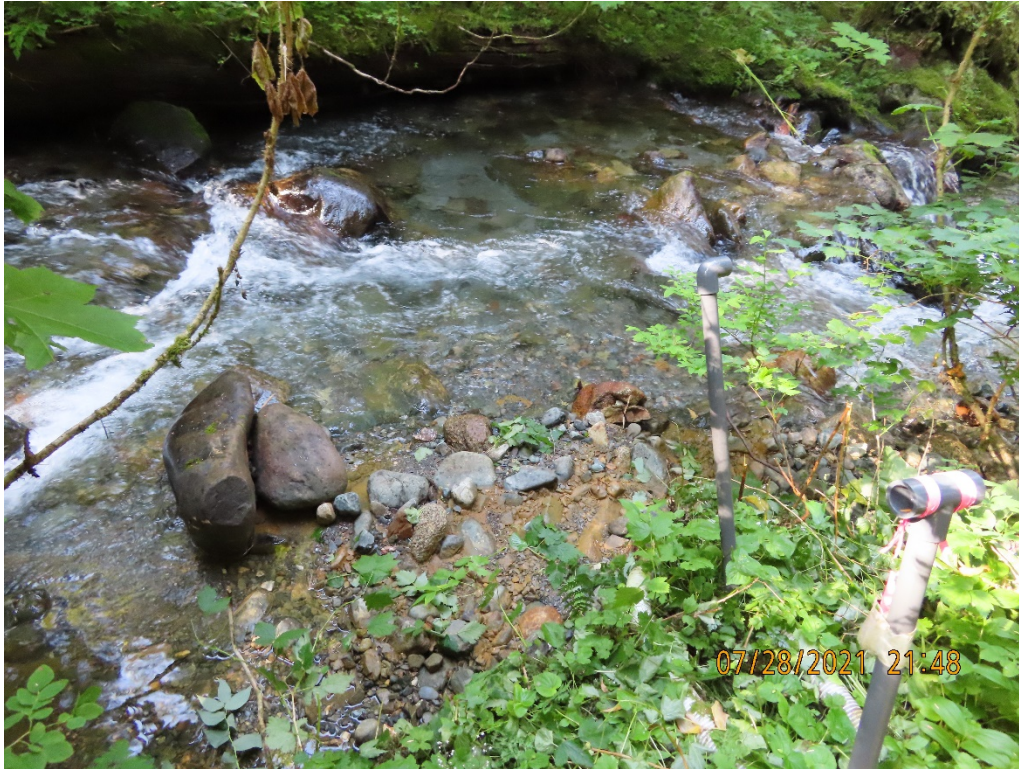
White material was not observed on the substrate in Sherman Creek (Photo 7). In the underground workings Z-Clear 129 continues to be added to seepage water at the lowermost sump. This coagulant is used in an attempt to remove flocculants and polymers used as underground drill additives that Coeur suspects contribute to the white material intermittently observed at the Sherman Creek Outfall.

Photo 7. Sherman Creek outfall absent of white material.

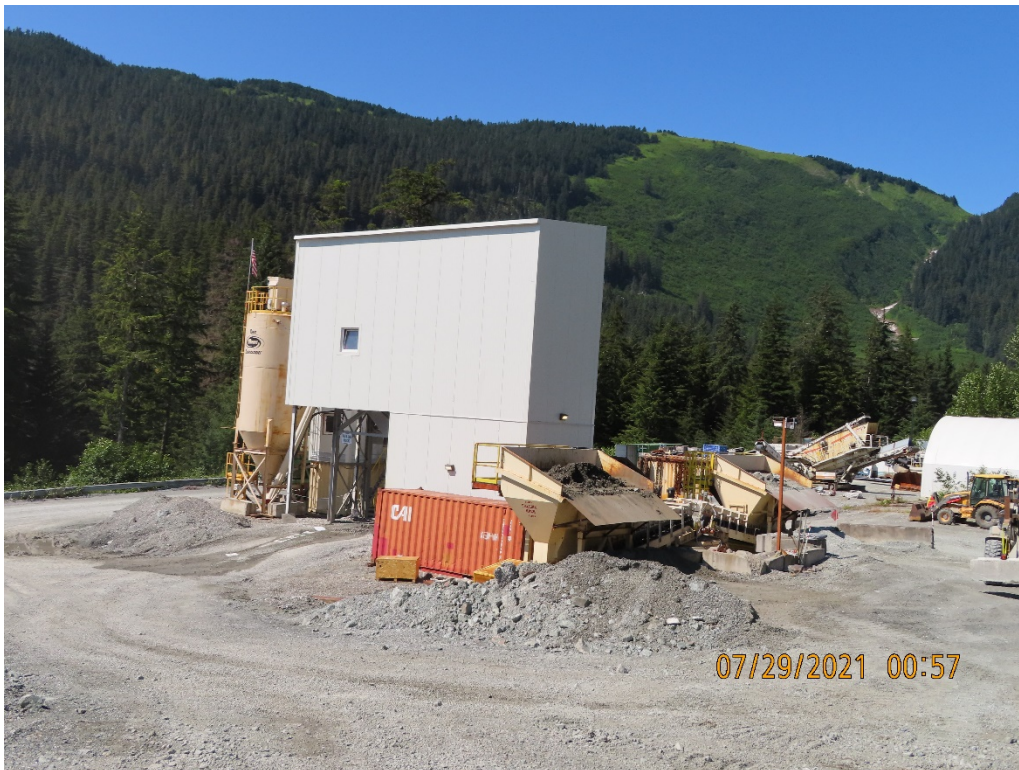
The pug plant was not operating at the time of inspection but has been operating intermittently this season (Photo 8). The pug plant is used to mix ARD-generating graphitic phyllite with concrete in preparation for underground backfill and storage to prevent impacts to surface resources. Mr. Eppers stated that Coeur Alaska hopes to have completed processing and backfilling all currently stockpiled graphitic phyllite by the end of 2022.

Photo 8. Pug plant.

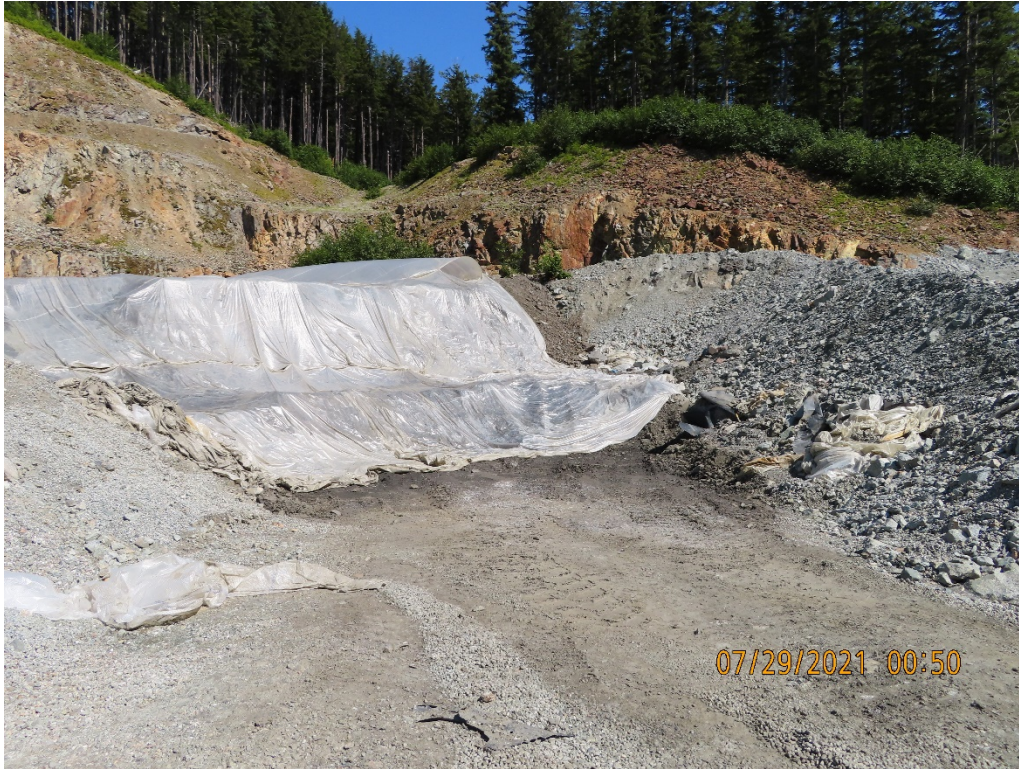
PENDING ACTION ITEM 182-2: Graphitic phyllite stored at this location is to be in covered and lined containment to manage ARD. A previous action item (182-2) was to repair the upper liner intended to prevent rainwater infiltration, and this has been completed (Photo 9). However, a light wind was intermittently inflating the liner at the time of inspection and a strong gust could damage it, so measures should be taken to prevent wind damage to the containment liner.

Photo 9. Graphitic phyllite stockpile at Pit 4.

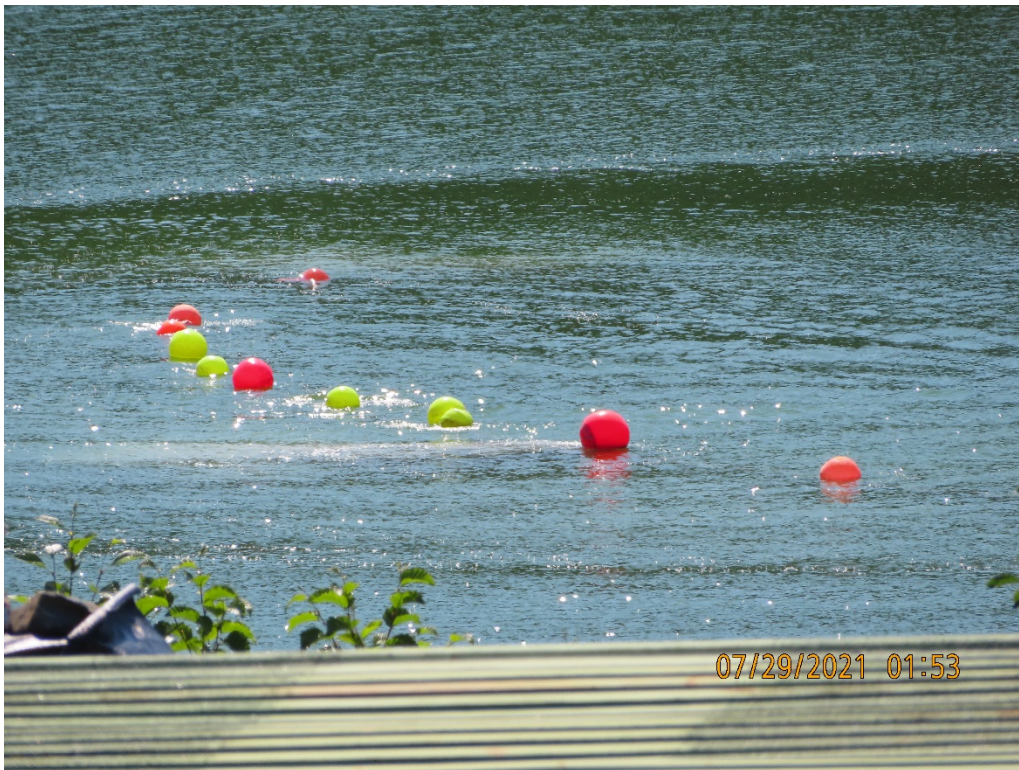
ACTION ITEM 183-1: Tailings placement has been shifted from the northwest to the northeast area of the TTF. A number of light colored areas were observed that did not appear to change in form or dissipate as would be expected of a suspended sediment plume (Photos 10-11). It should be determined whether these light areas maintain the nine-foot water depth requirement.

Photo 1. Northeast TTF tailings placement area showing light colored areas.

183-1: Determine the cause of light colored areas in the TTF to ensure the nine foot water depth requirement is being maintained (Photos 10-11).

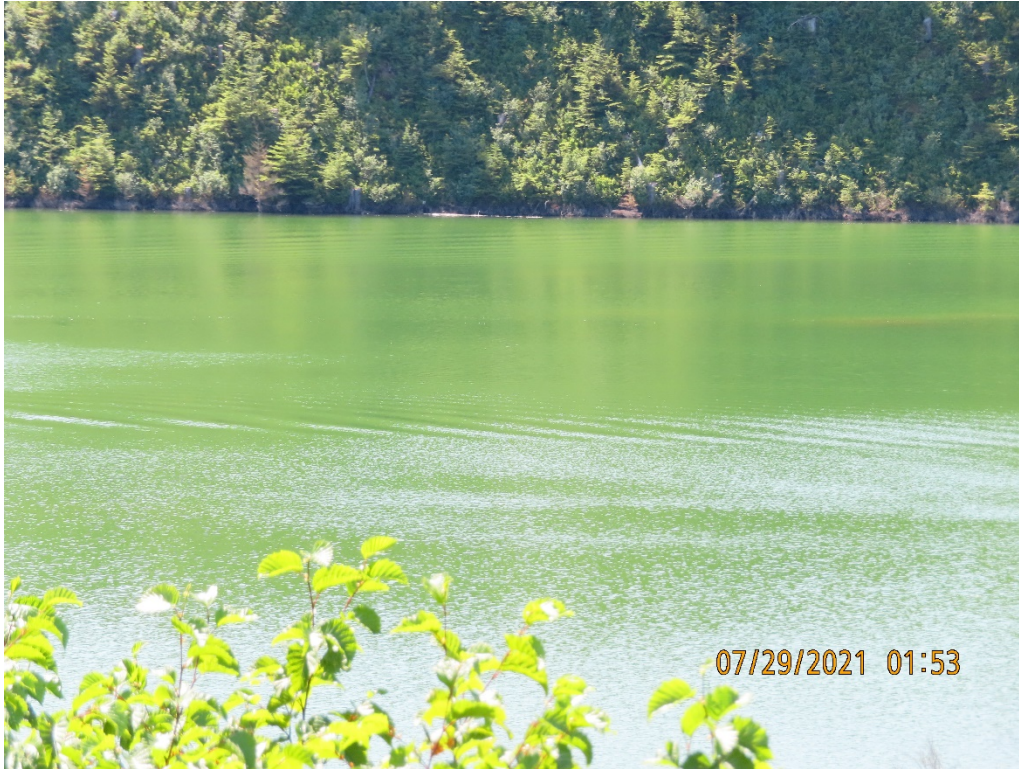
Photo 2. Northwest TTF tailings placement area showing light colored areas.

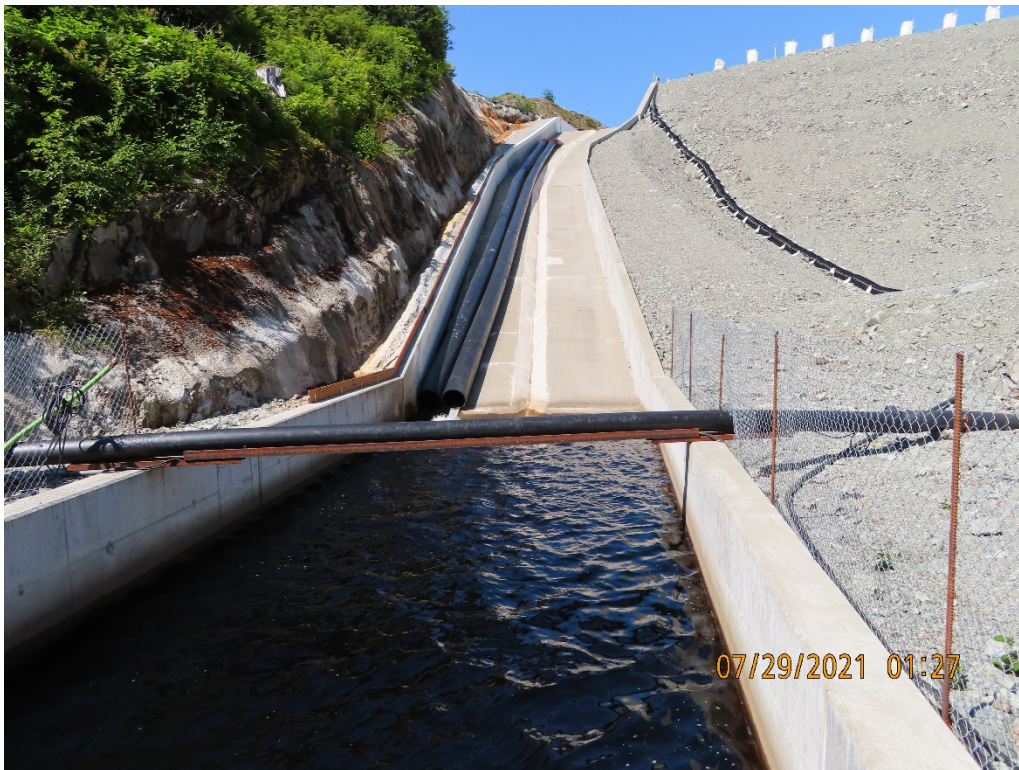
The TTF dam spillway was functioning as intended and free of debris. The acid rock drainage (ARD) diversion sill appeared to be preventing seepage of ARD into the dam spillway (Photo 12).

Photo 3. TTF dam spillway.

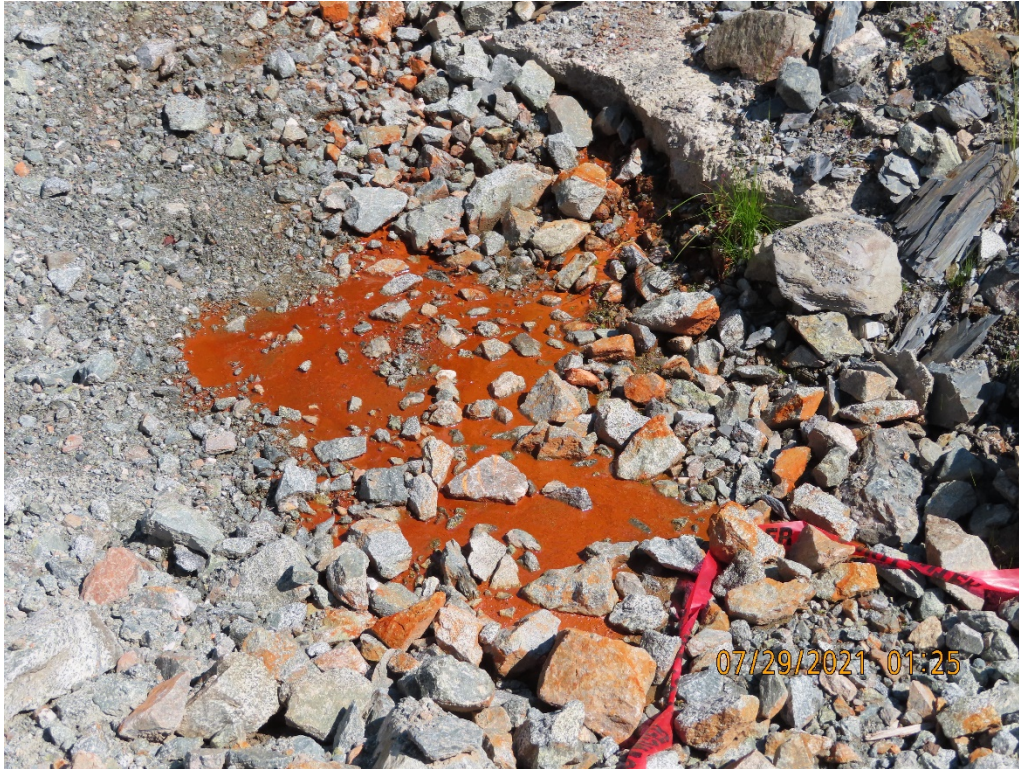
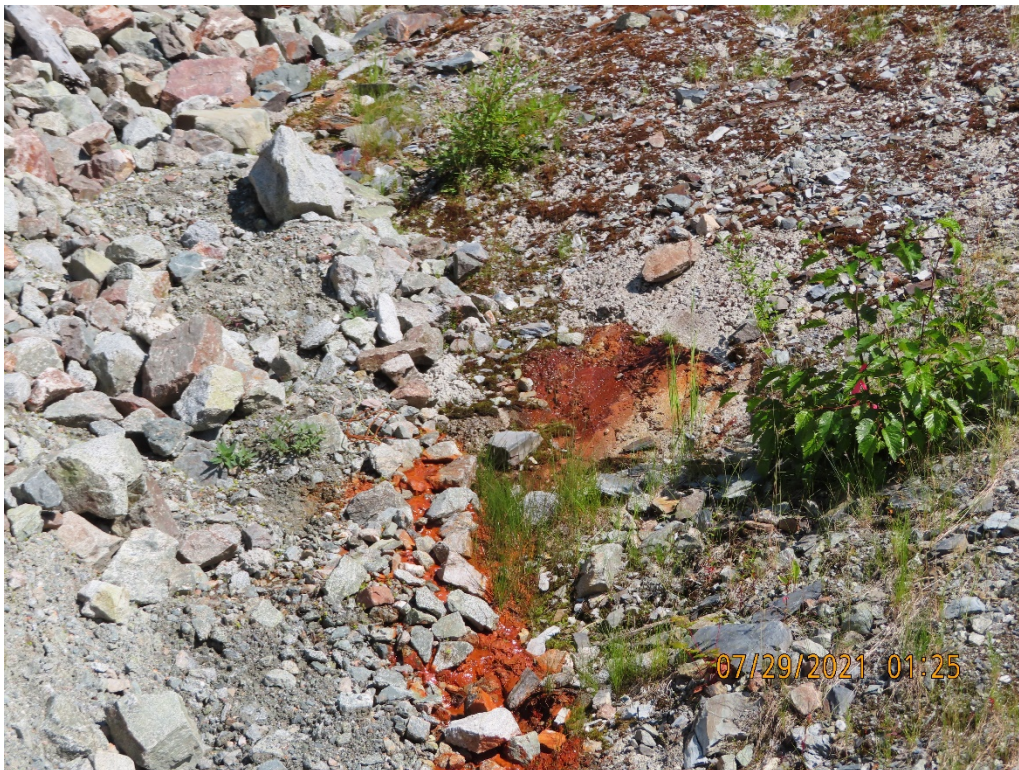
ACTION ITEM 183-2: South of the lower dam access road near the east abutment there is an apparent ARD seep (Photos 13-14). Though this water should be effectively captured for treatment by the existing seepage collection sumps, the origin and geochemical nature of the seepage should be investigated. Mr. Eppers stated samples would be collected and analyzed from this site.

Photo 4. Potential ARD seep near east TTF dam abutment.

Photo 5. Potential ARD seep near east TTF dam abutment.

183-2: Investigate the source and geochemistry of potential ARD seep near the east abutment of the TTF dam (Photos 13-14).

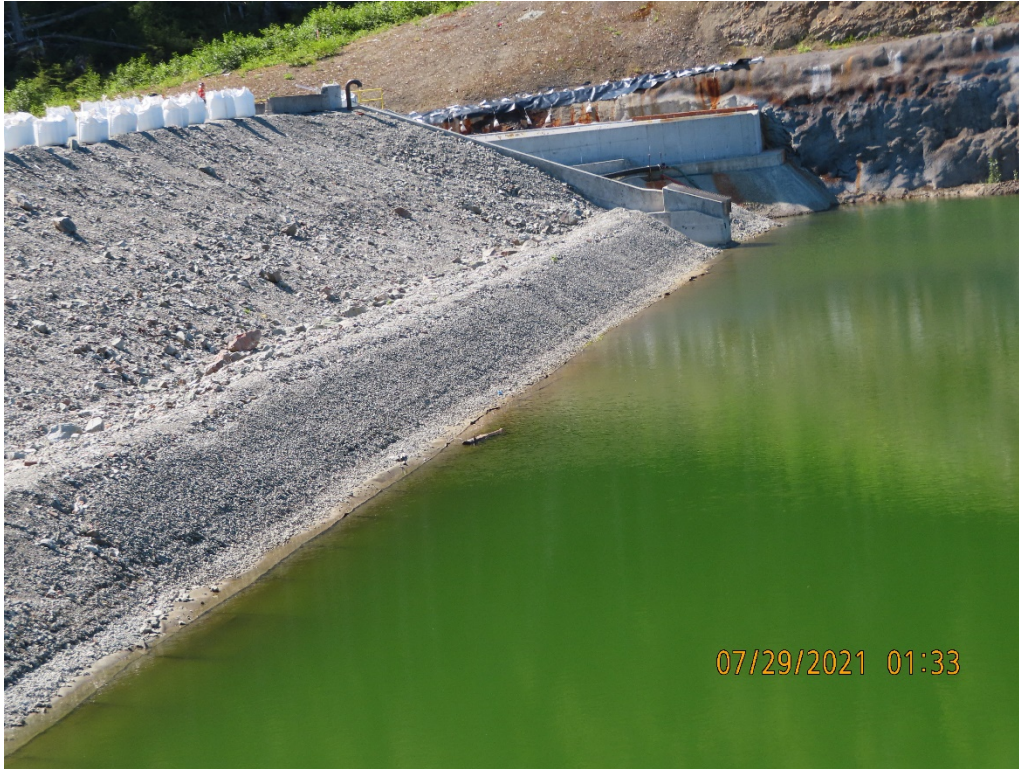
ACTION ITEM 183-3: There is a log against the face of the dam that should be removed (Photo 15)

Photo 15. Log against the face of the TTF dam.

183-3: Remove log from face of the TTF dam (Photo 15).

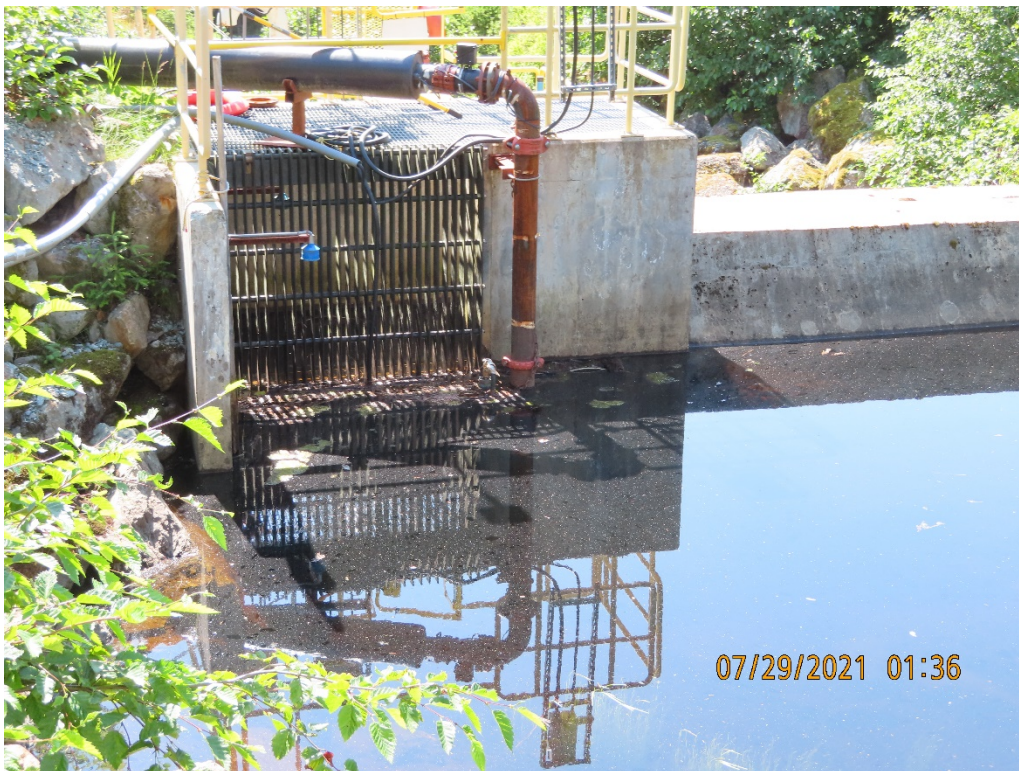
A previous action item (182-3) was to remove debris from the USL diversion intake structure, and this has been completed (Photo 16).

Photo 16. Upper Slate Lake diversion intake screen.

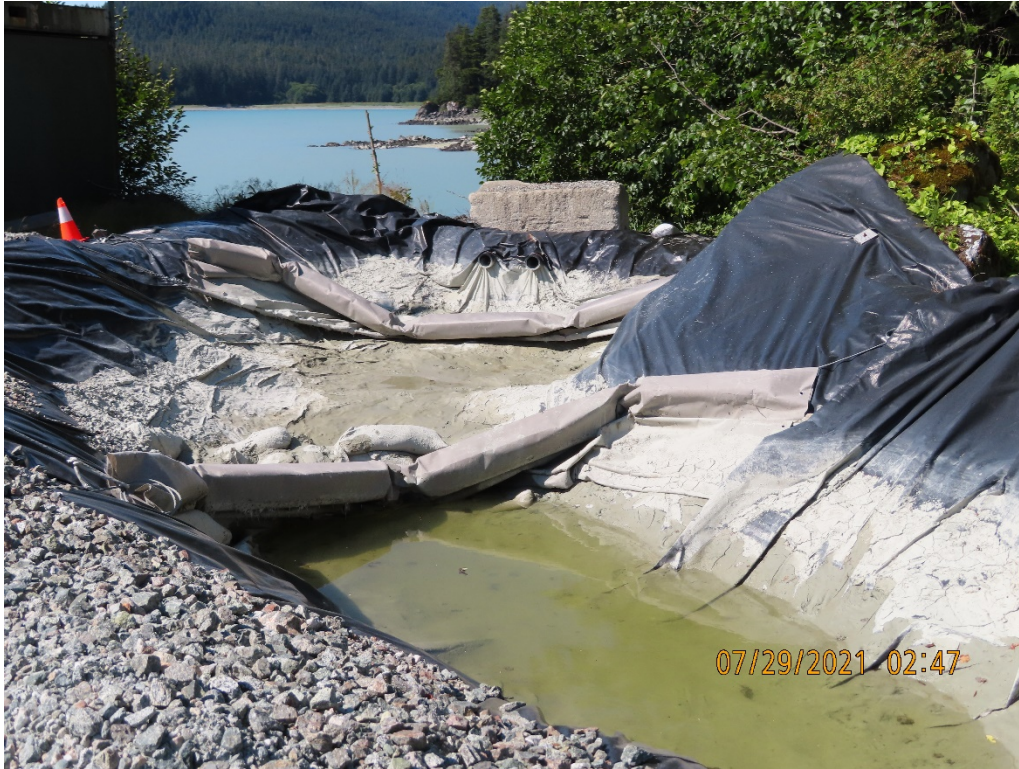
The stormwater BMPs by the port facility were in good condition (Photo 17).

Photo 17. Marine Terminal stormwater BMPs.
